Indies West Association, Inc.

## 2025 Structural Integrity Reserve Study

For Period Beginning April 1, 2025

2200 Gulf Shore Boulevard North, Naples, FL, 34102

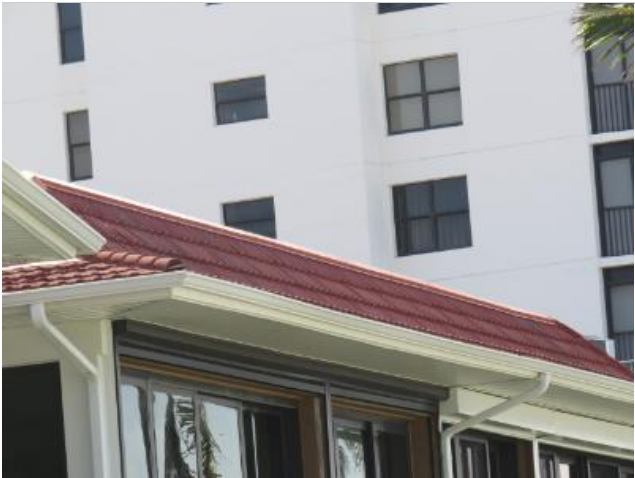
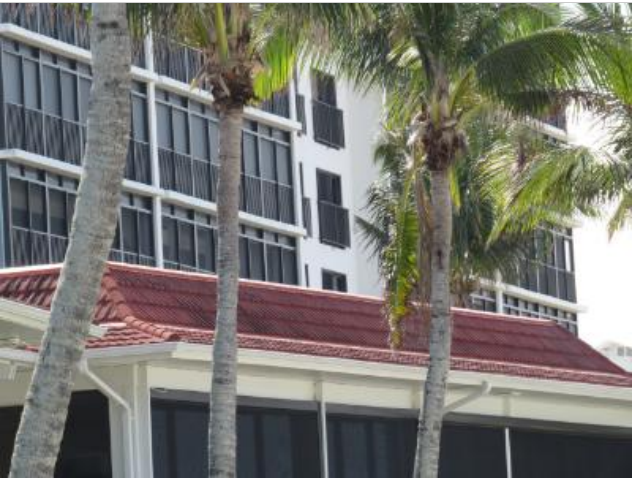
1 - Building A - Metal Roof Replacement

Type of Cost:	Replacement
Category:	Roof
Location:	Roof
Regulatory:	SIRS Requirement
Condition:	Fair

The building roof is divided into sloped stone coated metal tiles and a low-sloped modified bitumen built-up roof membrane that were installed circa 2006. The metal tiles generally have a useful life of 35- to 40-years, while the modified bitumen system generally has a useful life of 20- to 25-years. We understand the Association has had the flat portion of the roof coated with an aluminum protective coating as a maintenance program circa 2018. At the time of our site visit, both roof systems were observed to be in fair condition, with a few areas of needed roof repairs. We have included a reserve item for replacement of both roof systems.
